ArubaOS 6.2.1.2

Release Notes

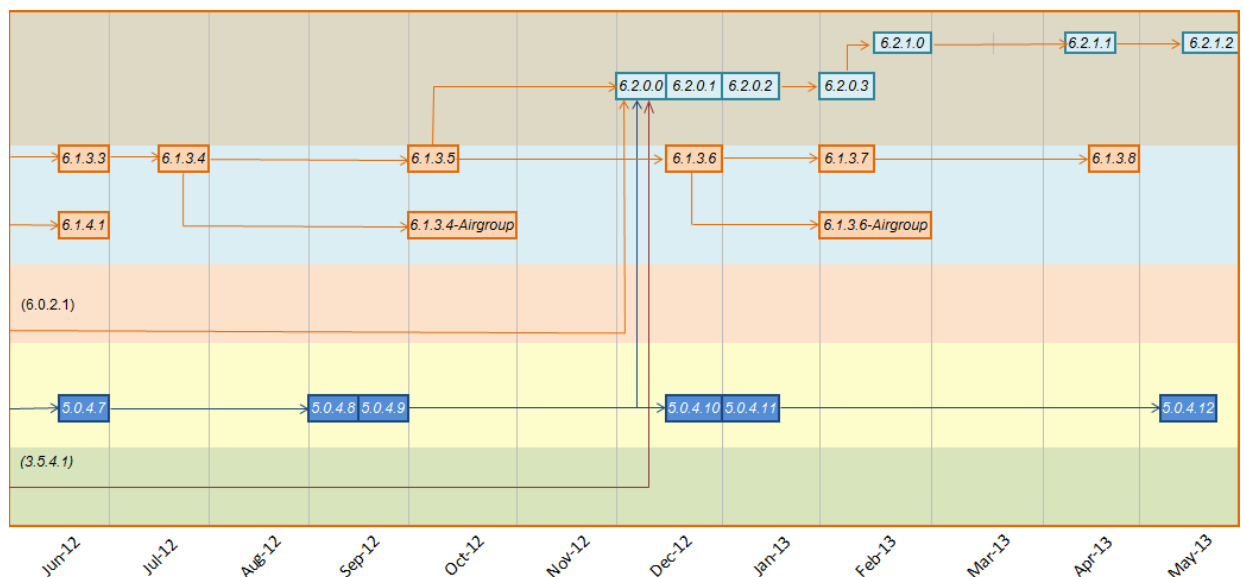
Figure 1 *ArubaOS Releases and Code Stream Integration*

The following illustration shows which patches and maintenance releases are included in their entirety in ArubaOS 6.2.1.2.
