# ArubaOS 5.0.4.9

Release Notes

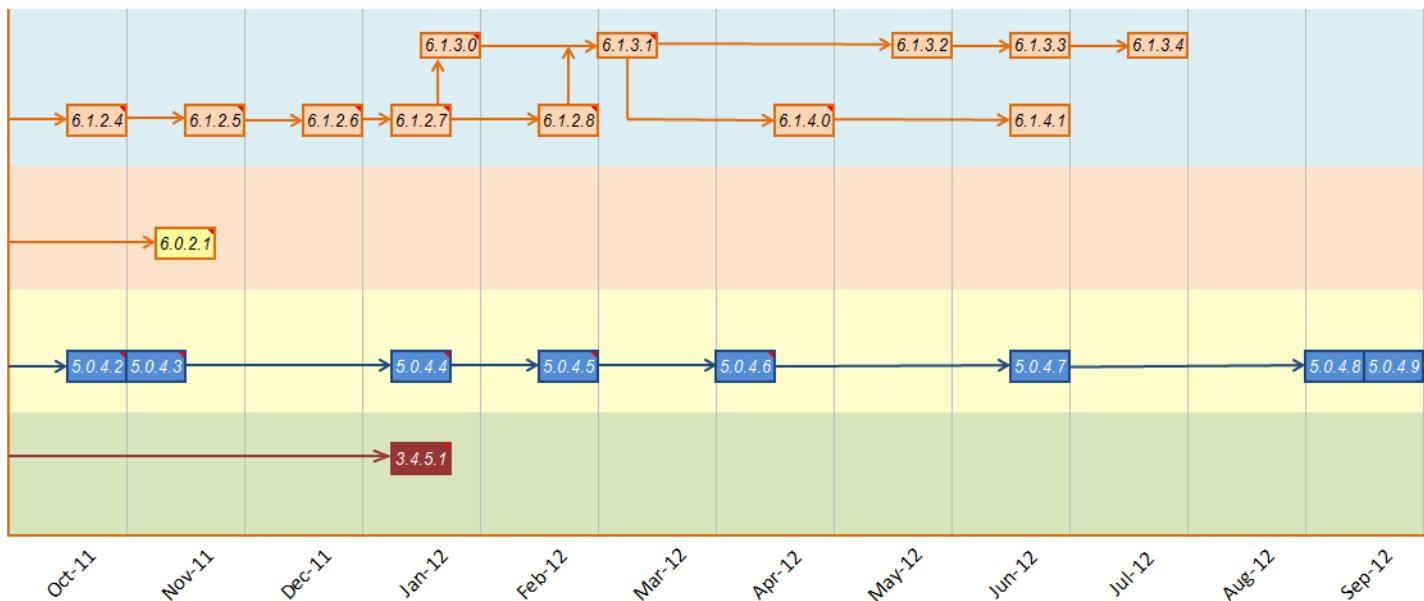
**Figure 1** ArubaOS Release Mapping

The following illustration shows which patches and maintenance releases are included in their entirety in ArubaOS 5.0.4.9.

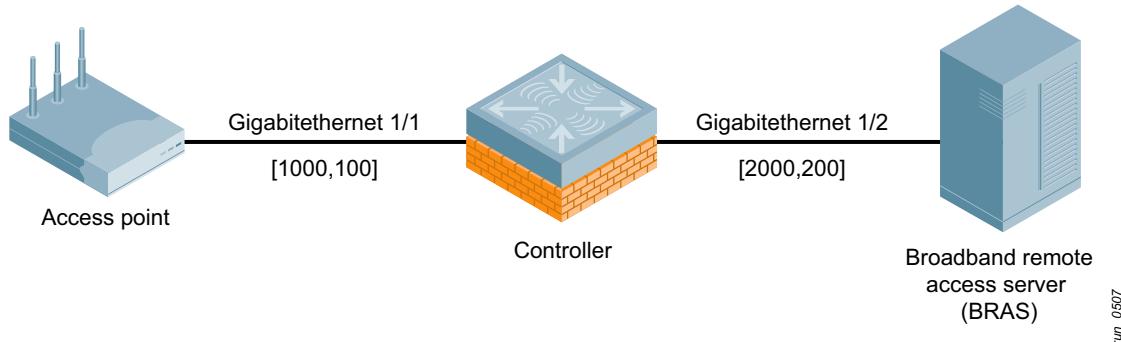
The following is a sample topology and the corresponding configuration.

```
interface gigabitethernet 1/1
  switch mode trunk
  switch trunk allow vlan 1000 <-define the broadcast domain as outer vlan on AP side
  encapsulation dot1q 1000 second-dot1q 100 <-use to the broadcast packet from Controller to AP
  qinq <-enable qinq in this port
vlan 1000
vlan 200
interface vlan 1000
  ip addr 192.168.1.1 255.255.255.0

ip dhcp pool AP
    network 192.168.1.0 255.255.255.0
  service dhcp
  ip access-list qinq bras
    permit 2000 200 pop <-define the vlan ACL used on BRAS side to pop the outer vlan
  interface gigabitethernet 1/2
    switch mode trunk
    switch trunk allow vlan 200 <-define the broadcast domain as inner_vlan in BRAS side
    qinq <-enable QinQ
    vlan-map-acl bras in <-apply the vlan ACL to pop the outer_vlan in BRAS side

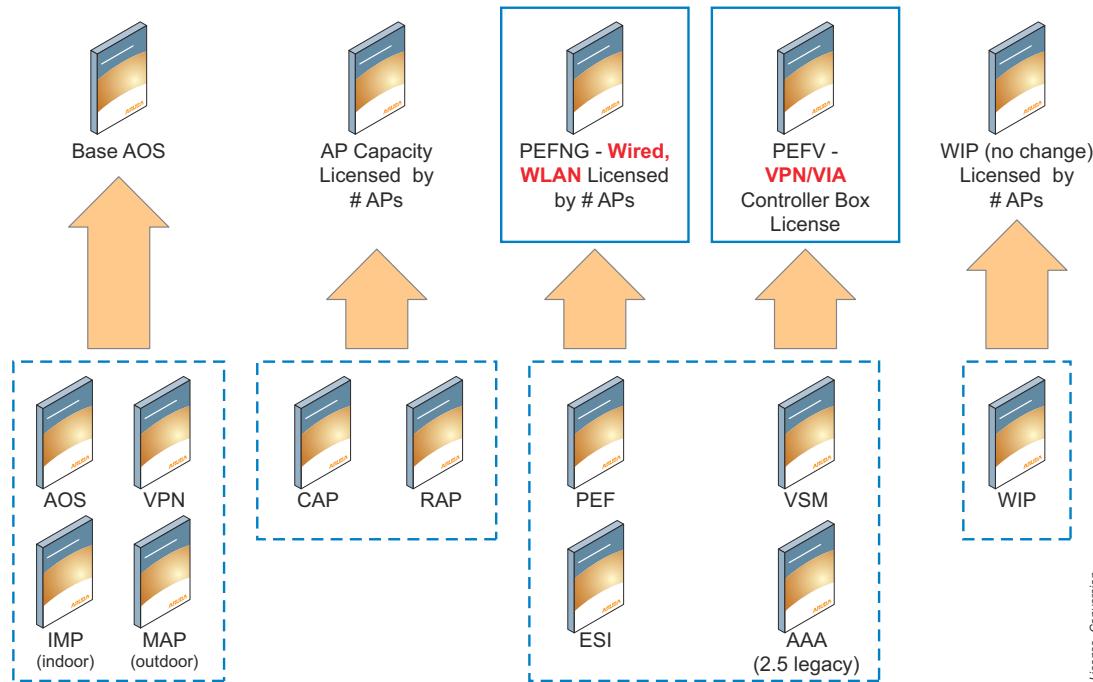
**Figure 2** License Consolidation

License consolidation and even renaming of licenses occur over time. [Figure 2](#) is an up-to-date illustration of the consolidated licenses effective with this release.

Software licenses in ArubaOS 5.0 are consolidated and in some instances license names and modules are renamed to more accurately represent the modules supported by the licenses (see [Figure 2](#)).
