ArubaOS 6.3.0.2

Release Notes

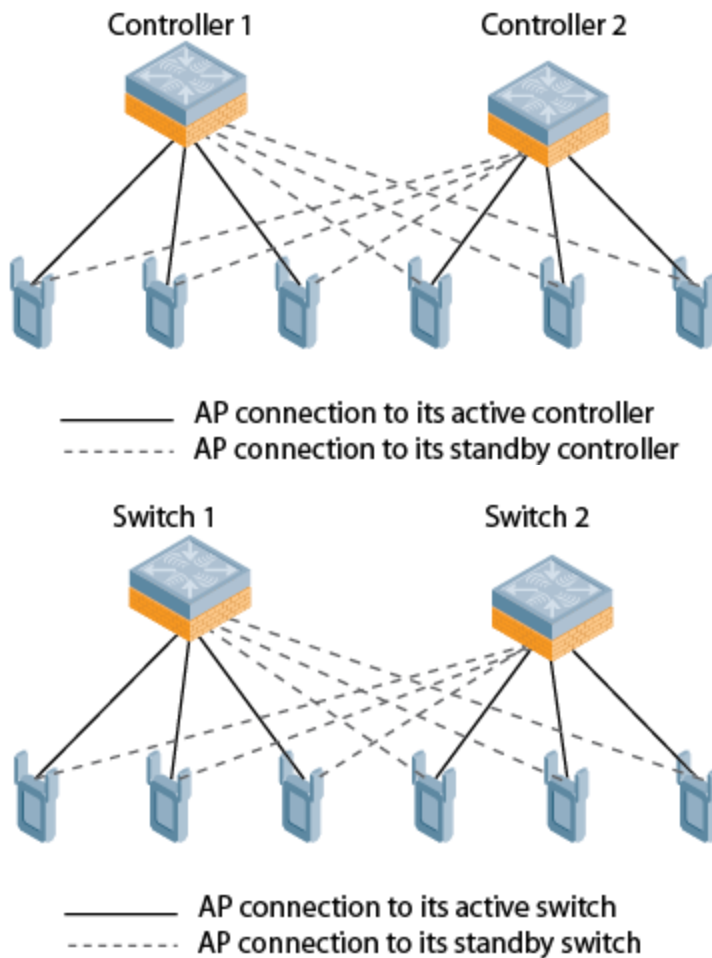
In this model, two controllers are deployed in dual mode. Controller one acts as standby for the APs served by controller two, and vice-versa. Each controller in this deployment model supports approximately 50% of its total AP capacity, so if one controller fails, all the APs served by that controller would fail over to the other controller, thereby providing high availability redundancy to all APs in the cluster.

Figure 2 Active-Active HA Deployment

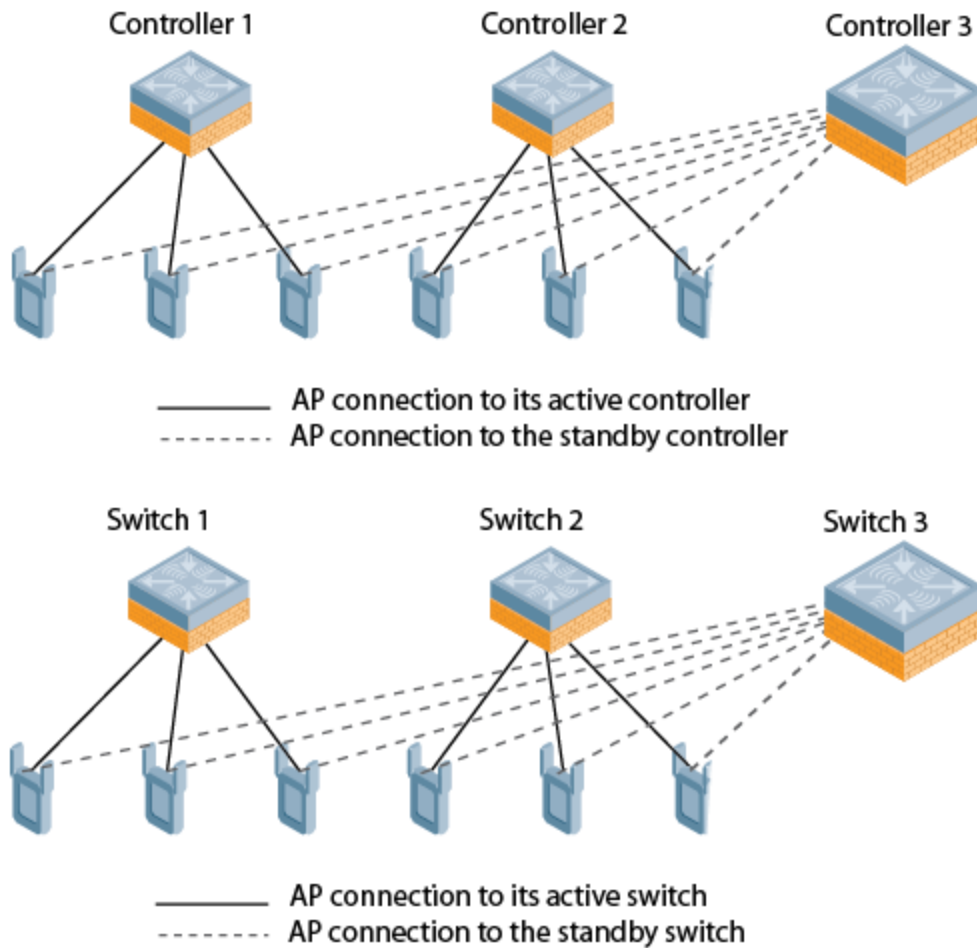
In this model, each controller in active mode supports up to 100% of its rated capacity of APs, while one other controller is idle in standby mode. If an active controller fails, all APs served by the active controller would failover to the standby controller.

In the cluster shown in the example below, two active controllers use a single higher-capacity standby controller.

Figure 4 1:1 Active/Standby Deployment
