ARUBA INSTANT BEST PRACTICES & TROUBLESHOOTING

Technical Climb Webinar

Presenter: Barath Srinivasan
barath.srinivasan@hpe.com

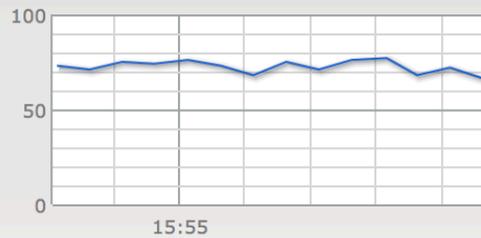
Utilization (%)

Radio 1: 2.4 GHz - Chan. 1
