# ArubaOS 6.1.3.9

Release Notes

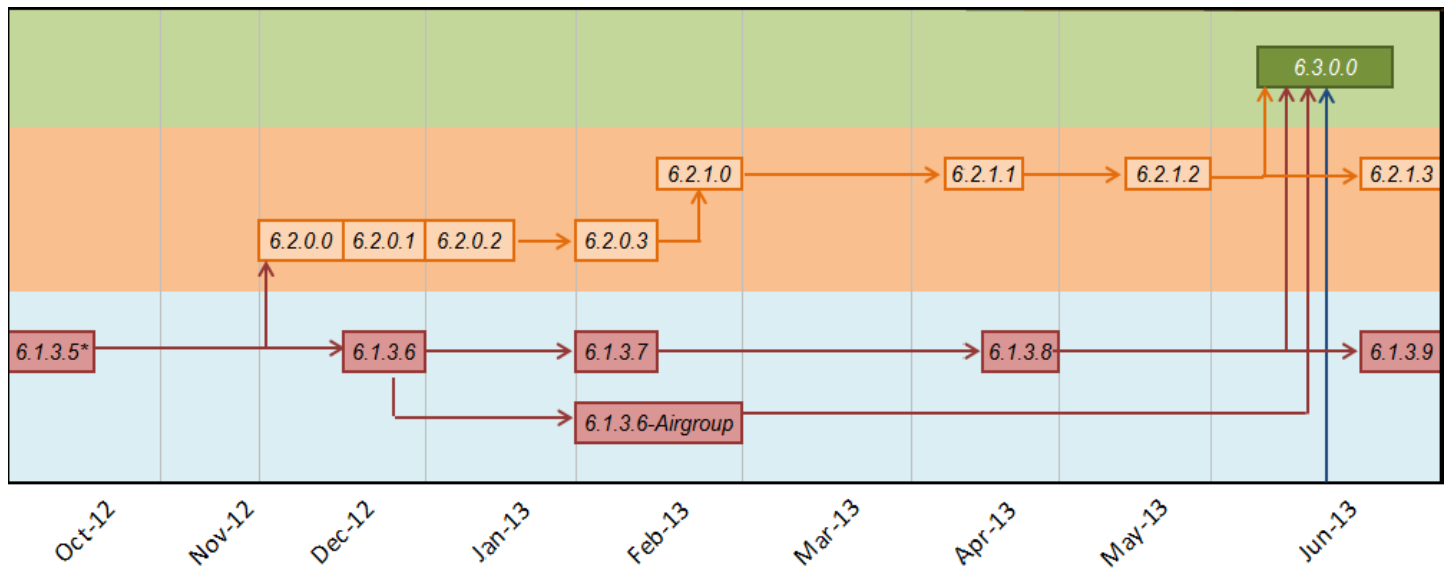
**Figure 1** ArubaOS Releases and Code Stream Integration

The following illustration shows the patches and maintenance releases included in ArubaOS 6.1.3.9:

\*6.1.3.0 contains 6.0.1.2, 5.0.3.3, and 3.4.4.2 patch content
