TAC Madison Lee Giles Scott

eSupport Project Update

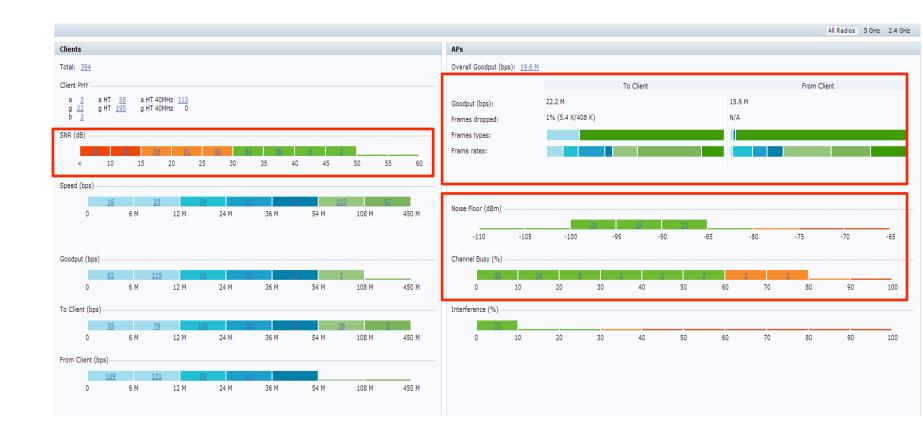
Aruba Dashboard

Is your RF environment Healthy?

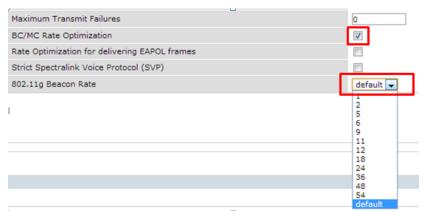
Drop Broadcasts on Virtual-Aps as long as it is not required

Remove data rates 1,2 Mbps from Tx and Basic rates (in ALL

SSIDs)

- Enable (BC/MC Optimization) in ALL your configured SSIDs
- If you have many SSIDs (more than 4 SSID) make sure to use higher data rate for Beacons

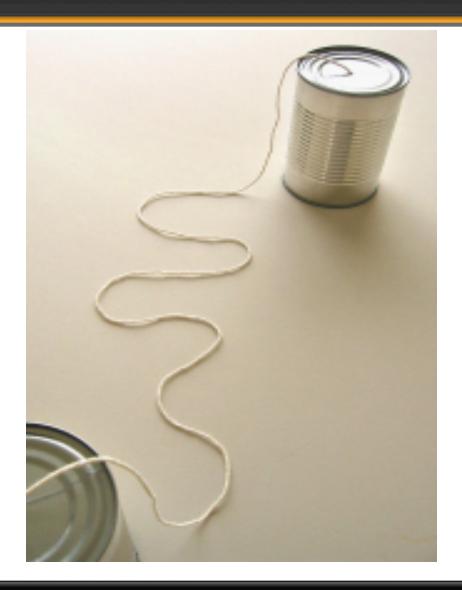
Wi-Fi Client to AP RF association Requires 2 devices.

Each device must transmit to, and receive from the other device for the connection to work.

The Tin Can Telephone requires **TWO** cans.

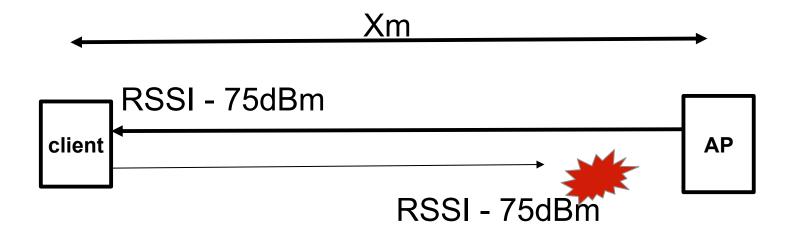
Wi-Fi Client RF association to an AP is **TWO WAY** communication Each participant must send to, and receive from the other side. Over a given distance, the client may "hear" the AP fine.

But if the AP cannot "hear" the client at the same distance...

The AP can transmit at higher raw power than a mobile device.

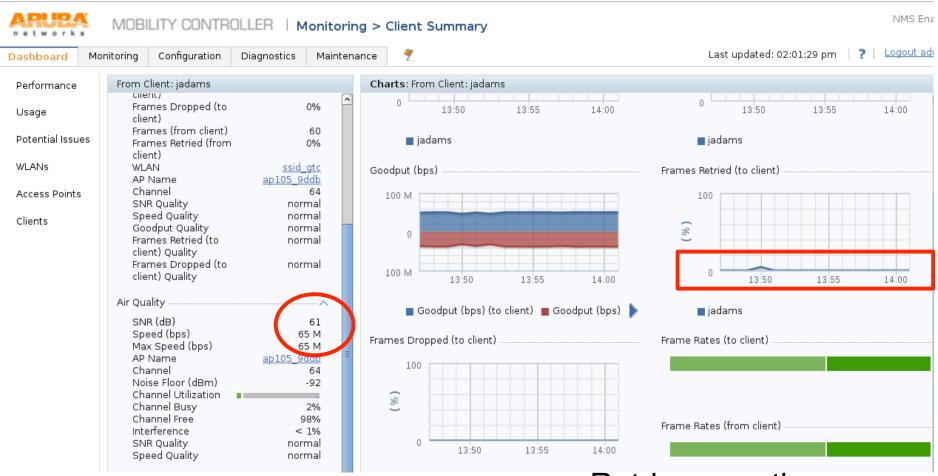
Use the controller dashboard/monitoring screens or CLI commands To verify received signal strength, data rates, and retries at **both** ends

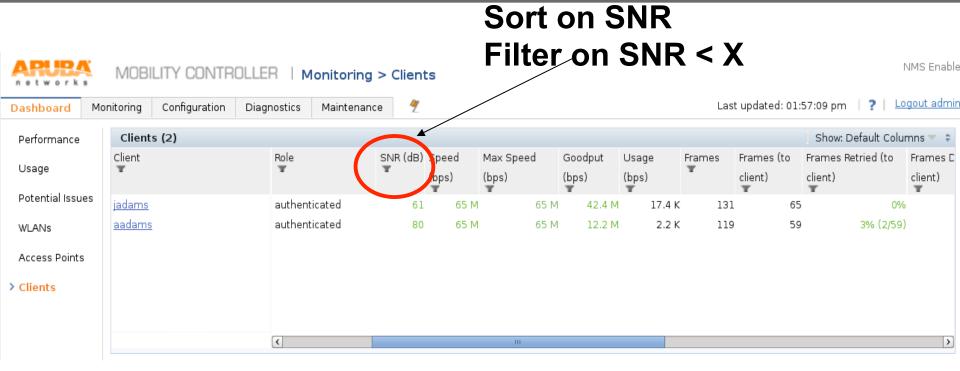
Retries over time
Correlate to frame loss

"ArubaOS CLI:

Show ap debug client-table ap-name <apname>
<a>show ap debug mgmt-frames client-mac <mac address>

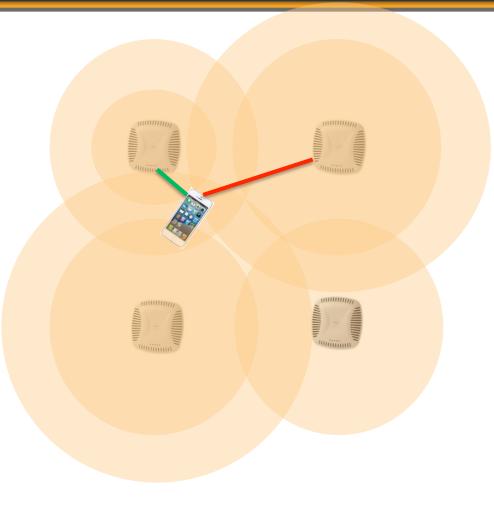
ARM Settings

Min Tx EIRP Max Tx EIRP

Data Rate Settings

Disable low data rates

- Local-Probe-Request threshold
- 6.3 Client-Match
