# ArubaOS 6.2

Release Notes

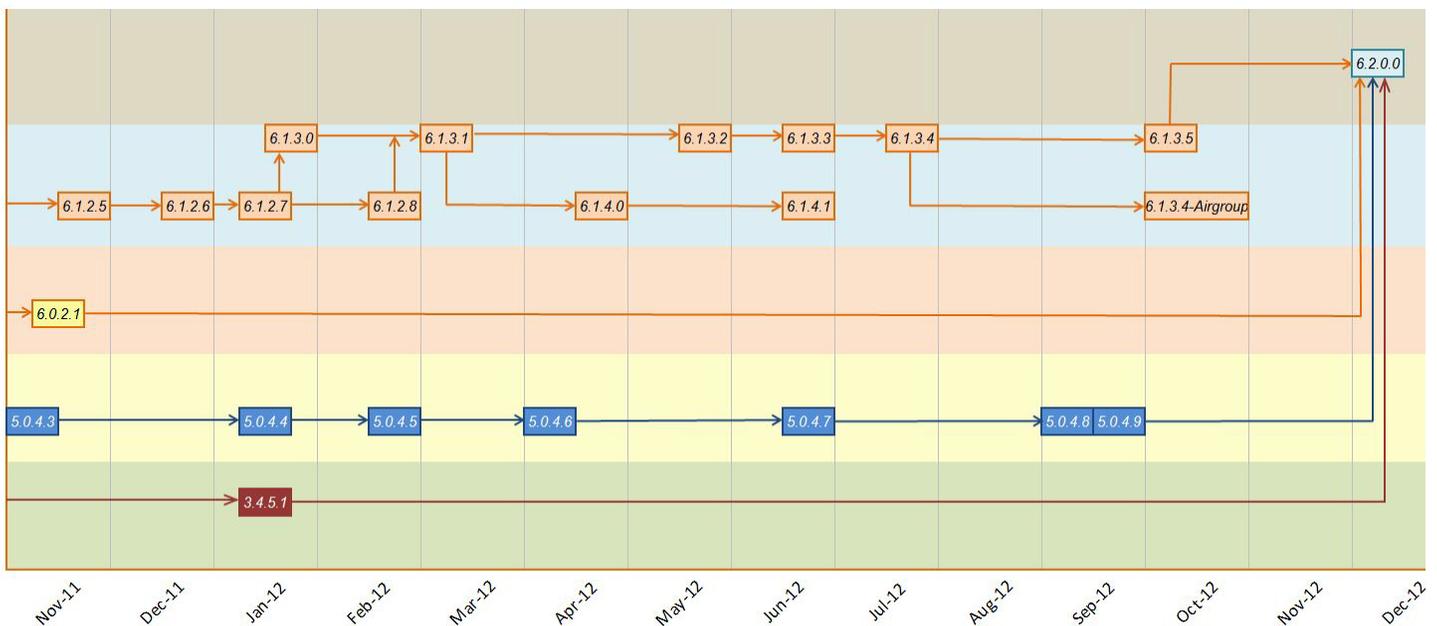
**Figure 1** ArubaOS Releases and Code Stream Integration

The following illustration shows which patches and maintenance releases are included in their entirety in ArubaOS 6.2.
