# ArubaOS 6.2.1.4

Release Notes

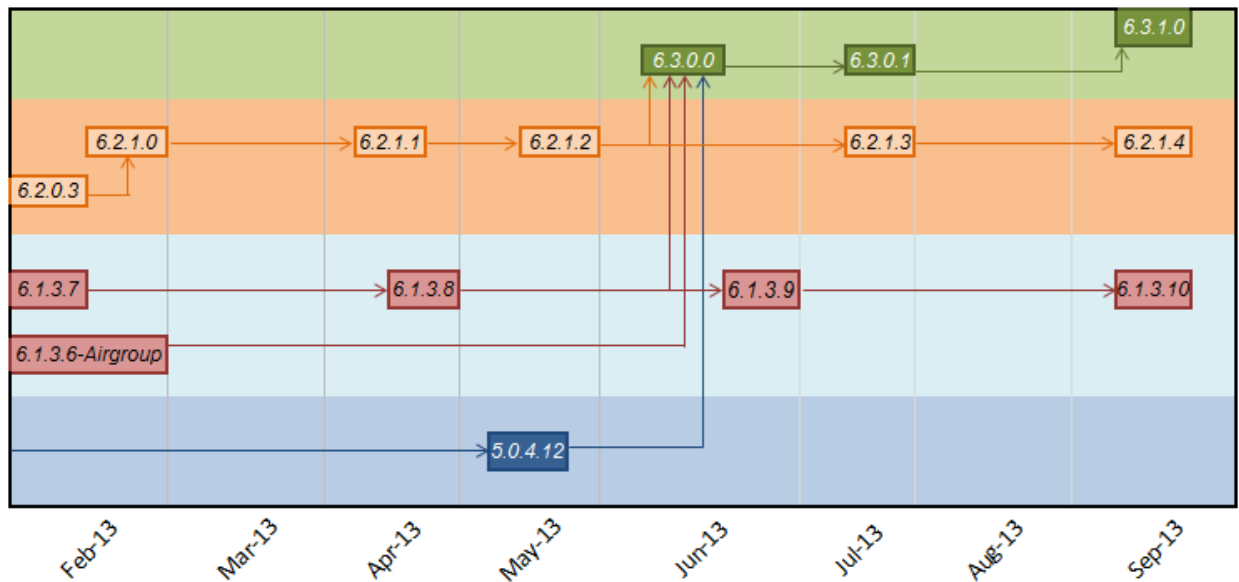
**Figure 1** *ArubaOS Releases and Code Stream Integration*

The following illustration shows which patches and maintenance releases are included in their entirety in ArubaOS 6.2.1.4.
