ArubaOS 5.0.3.3

Release Note

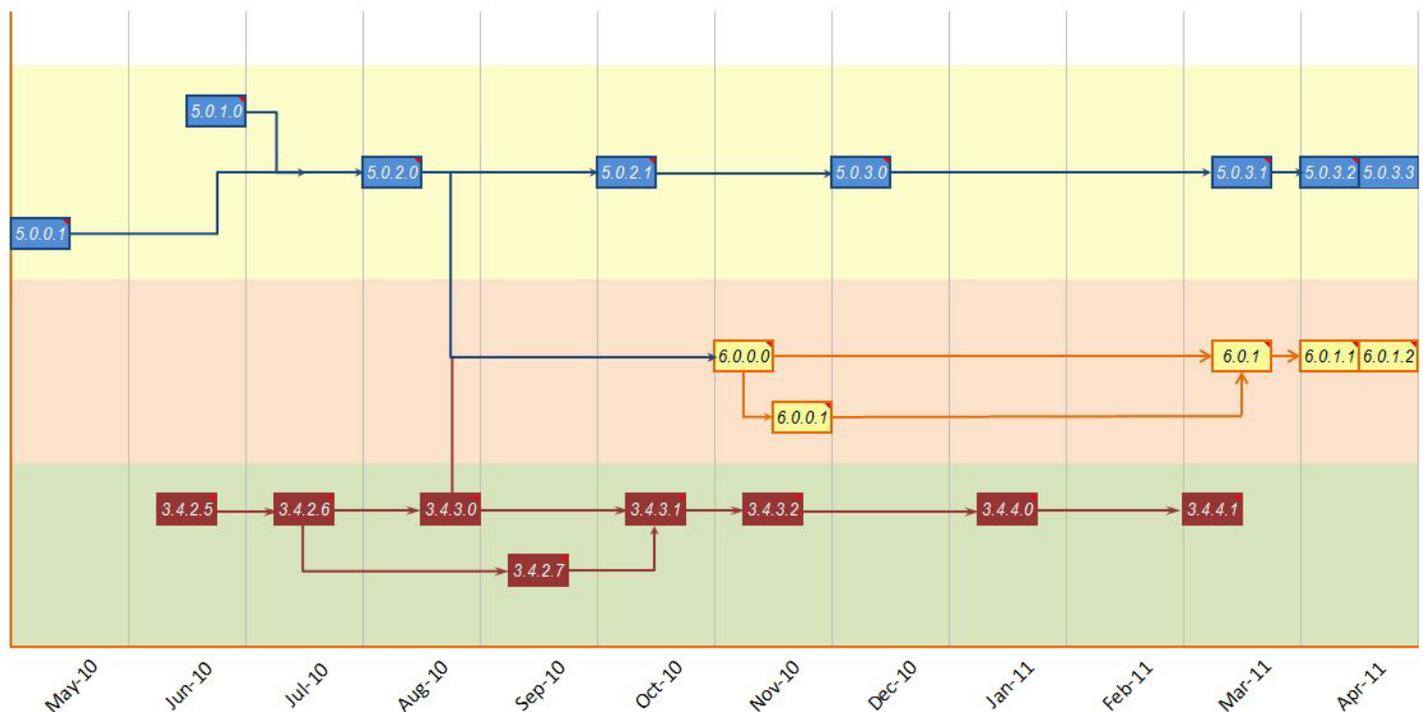
Figure 1 ArubaOS Release Mapping

The following illustration shows which patches and maintenance releases are included in their entirety in ArubaOS 5.0.3.1.

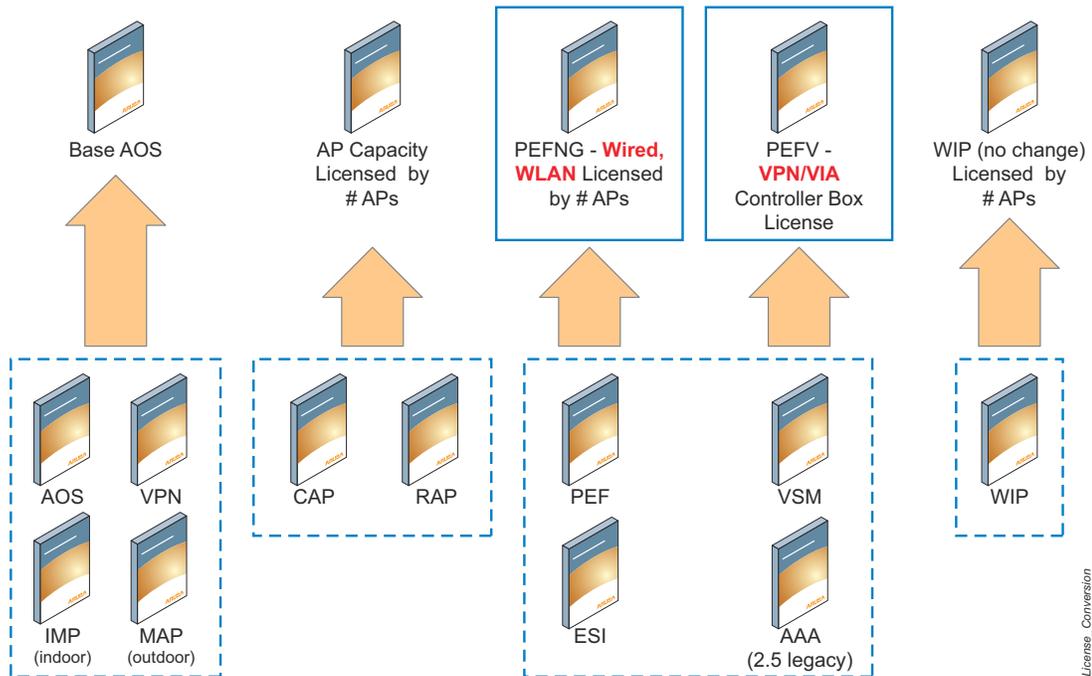
Figure 2 License Consolidation

License consolidation and even renaming of licenses occur over time. [Figure 2](#) is an up-to-date illustration of the consolidated licenses effective with this release.

Software licenses in ArubaOS 5.0 are consolidated and in some instances license names and modules are renamed to more accurately represent the modules supported by the licenses (see [Figure 2](#)).
