ArubaOS 6.1

Release Notes

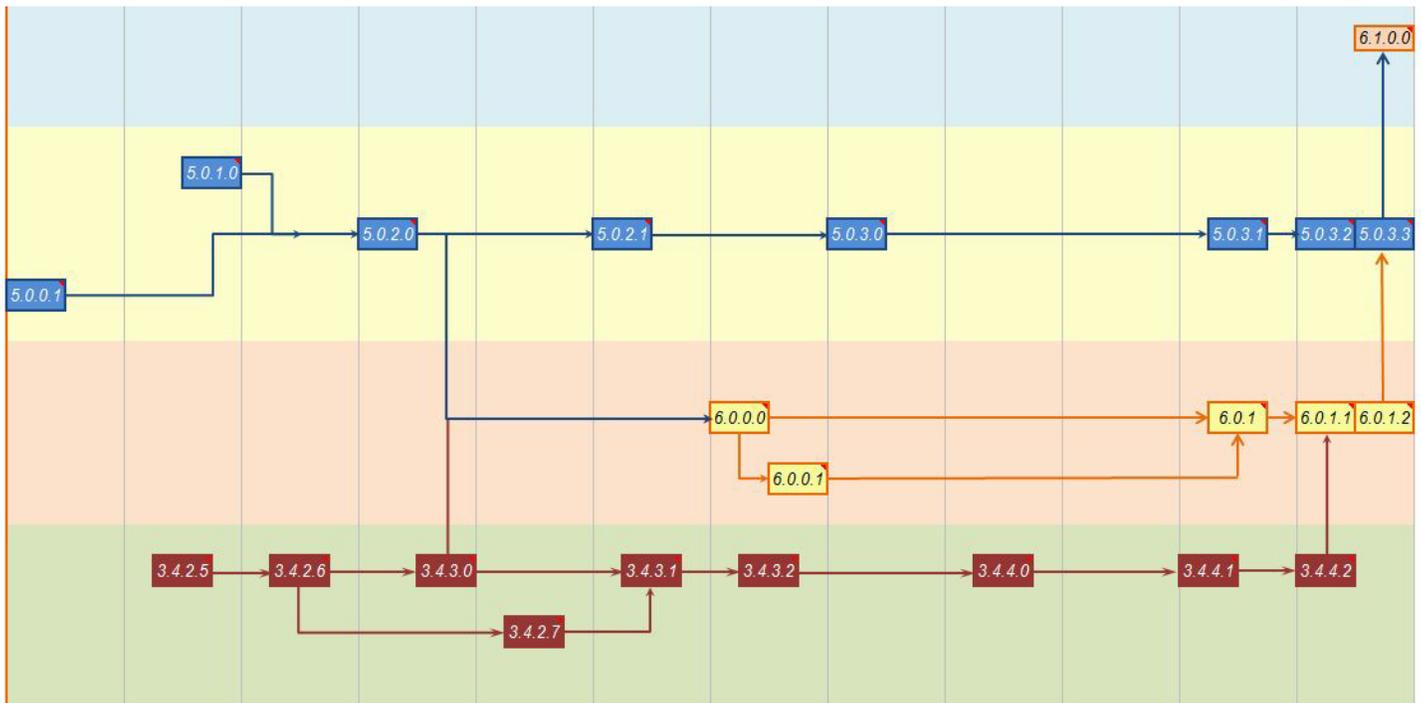
Figure 1 ArubaOS Releases and Code Stream Integration

The following illustration shows which patches and maintenance releases are included in their entirety in ArubaOS 6.1.

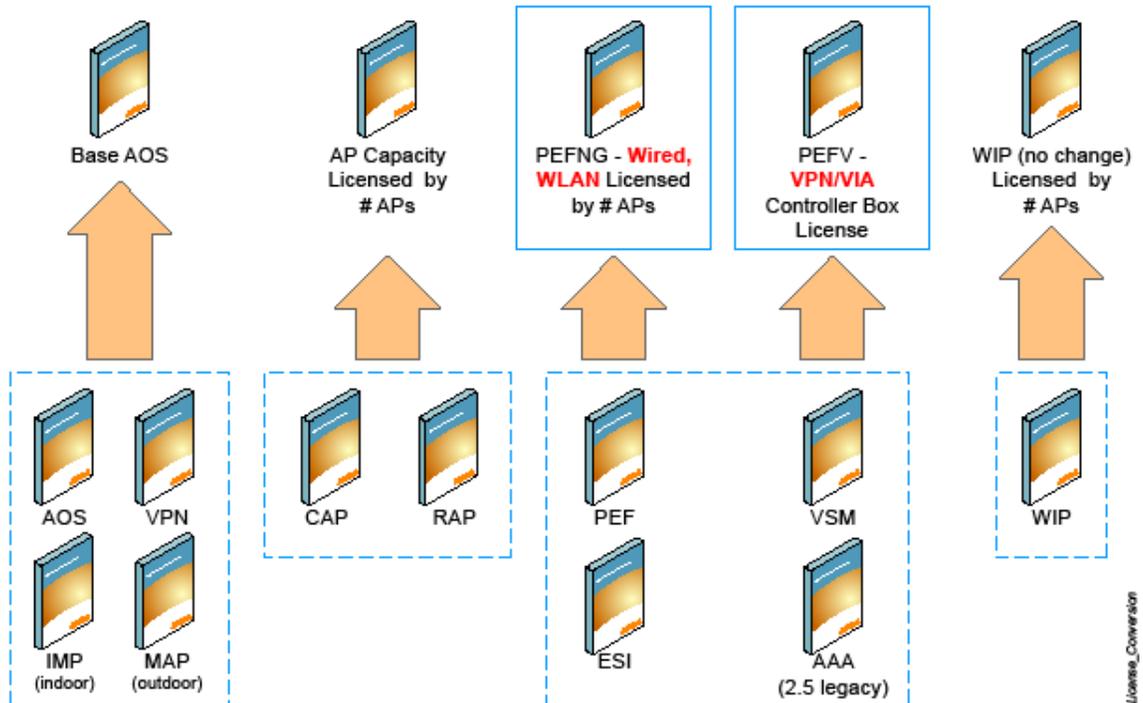
Figure 1 Licensing Consolidation ArubaOS 5.0

Figure 1 is an up-to-date illustration of the consolidated licenses effective with this release.

Software licenses in ArubaOS 5.0 were consolidated and in some instances license names and modules were renamed to more accurately represent the modules supported by the licenses (see [Figure 1](#)).
