ArubaOS 6.2

Release Notes

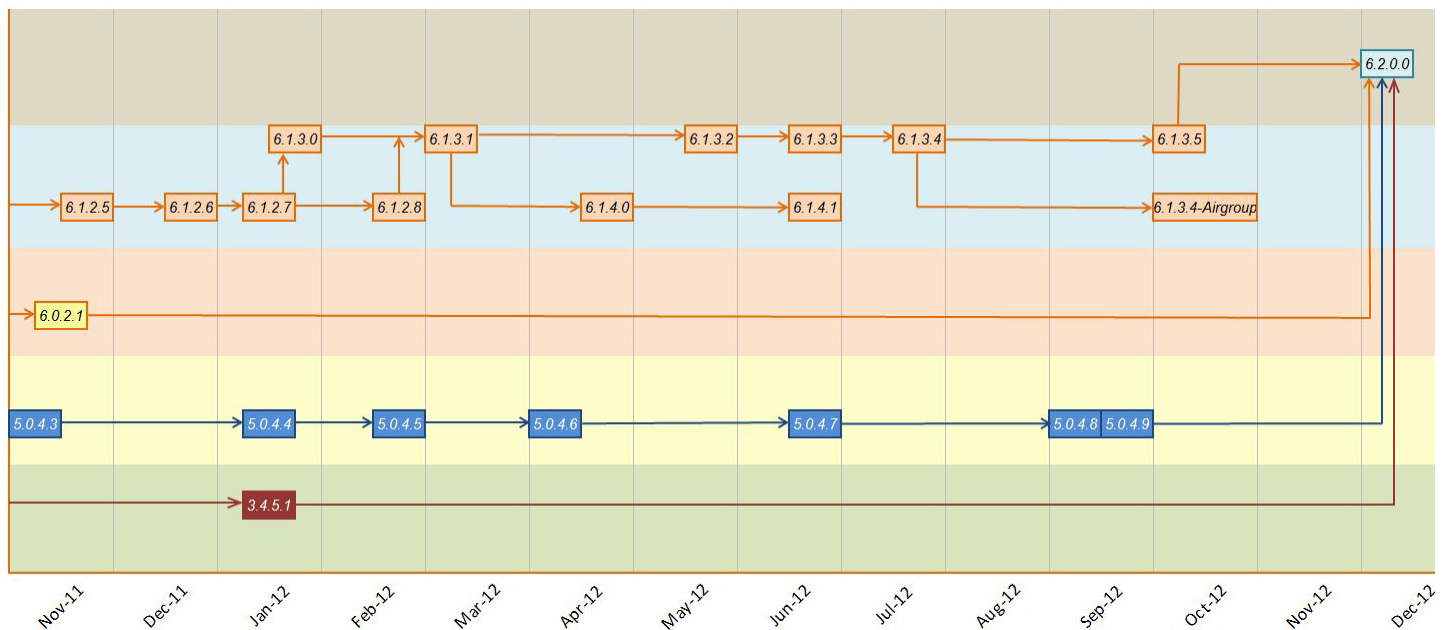
Figure 1 ArubaOS Releases and Code Stream Integration

The following illustration shows which patches and maintenance releases are included in their entirety in ArubaOS 6.2.
