ArubaOS 6.3.1

Release Notes

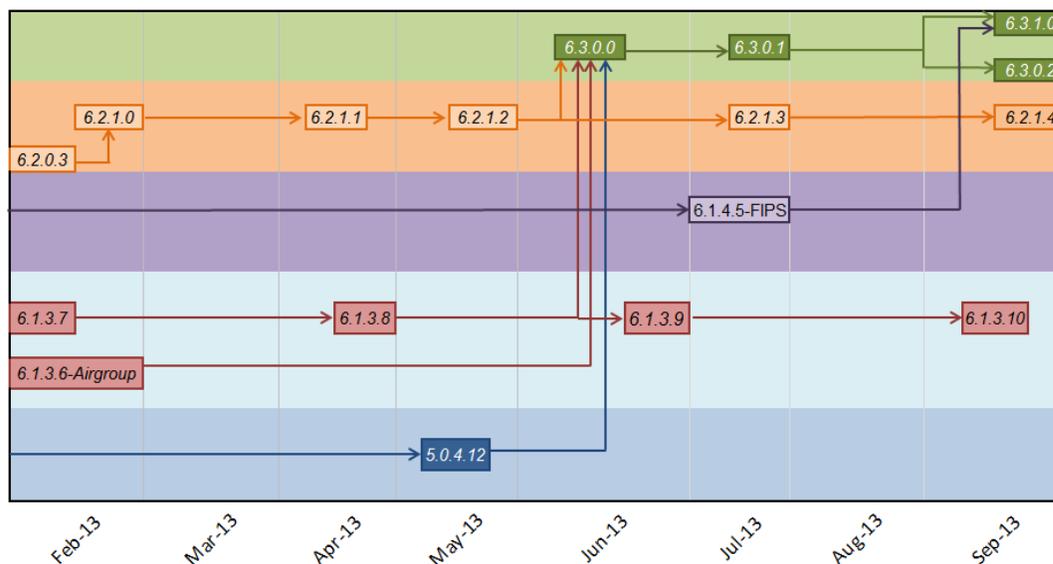
Figure 1 *ArubaOS Releases and Code Stream Integration*

The following illustration shows the patch and maintenance releases that are included in their entirety in ArubaOS 6.3.1.0:

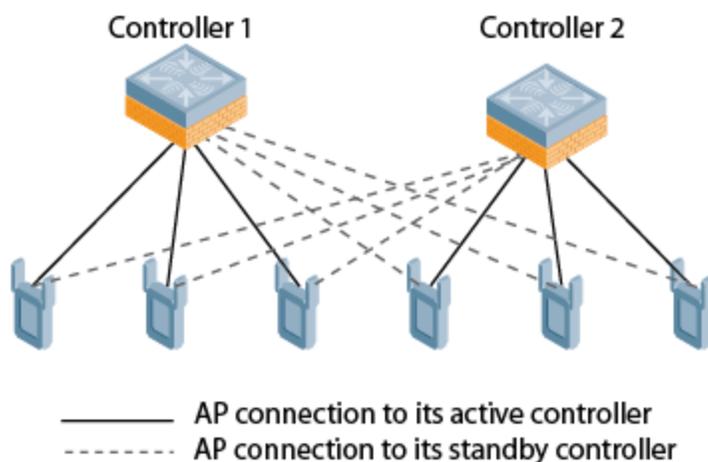
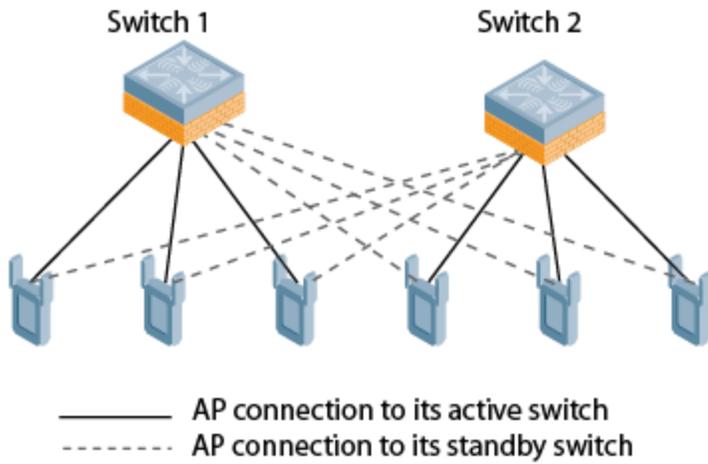
Figure 2 Active-Active HA Deployment

In this model, two controllers are deployed in dual mode. Controller one acts as standby for the APs served by controller two, and vice-versa. Each controller in this deployment model supports approximately 50% of its total AP capacity, so if one controller fails, all the APs served by that controller would fail over to the other controller, thereby providing high availability redundancy to all APs in the cluster.

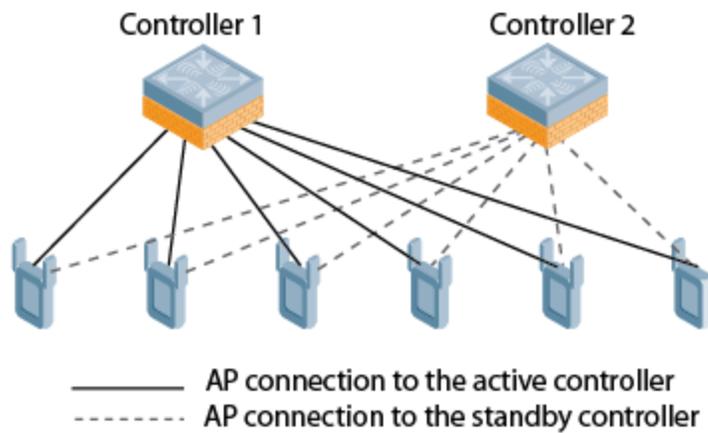
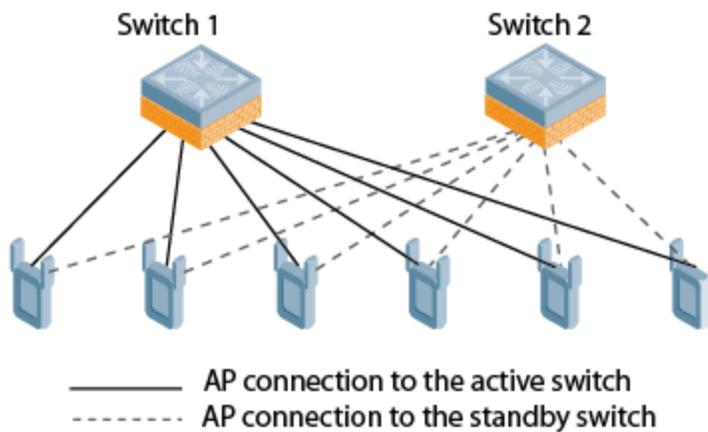
Figure 3 1:1 Active/Standby Deployment

In this model, the active controller supports up to 100% of its rated AP capacity, while the other controller in standby mode is idle. If the active controller fails, all APs served by the active controller would failover to the standby controller.

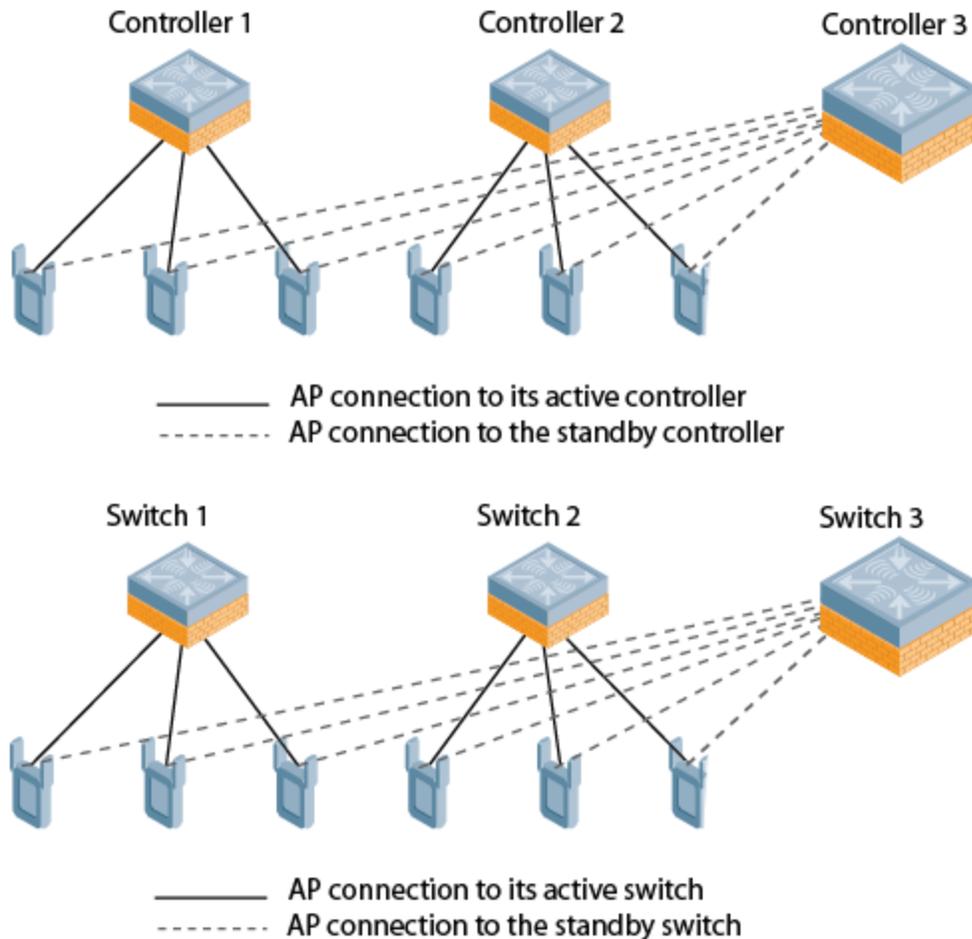
Figure 4 1:1 Active/Standby Deployment

In the cluster shown in the example below, the standby controller has enough AP capacity to support the total number of APs terminating on the active controllers. (Controller1 and Controller2)
