Non ISSU Upgrade

MAD BFD IRF upgrade procedure

Non ISSU Procedure to upgrade IRF stack using MAD BFD.

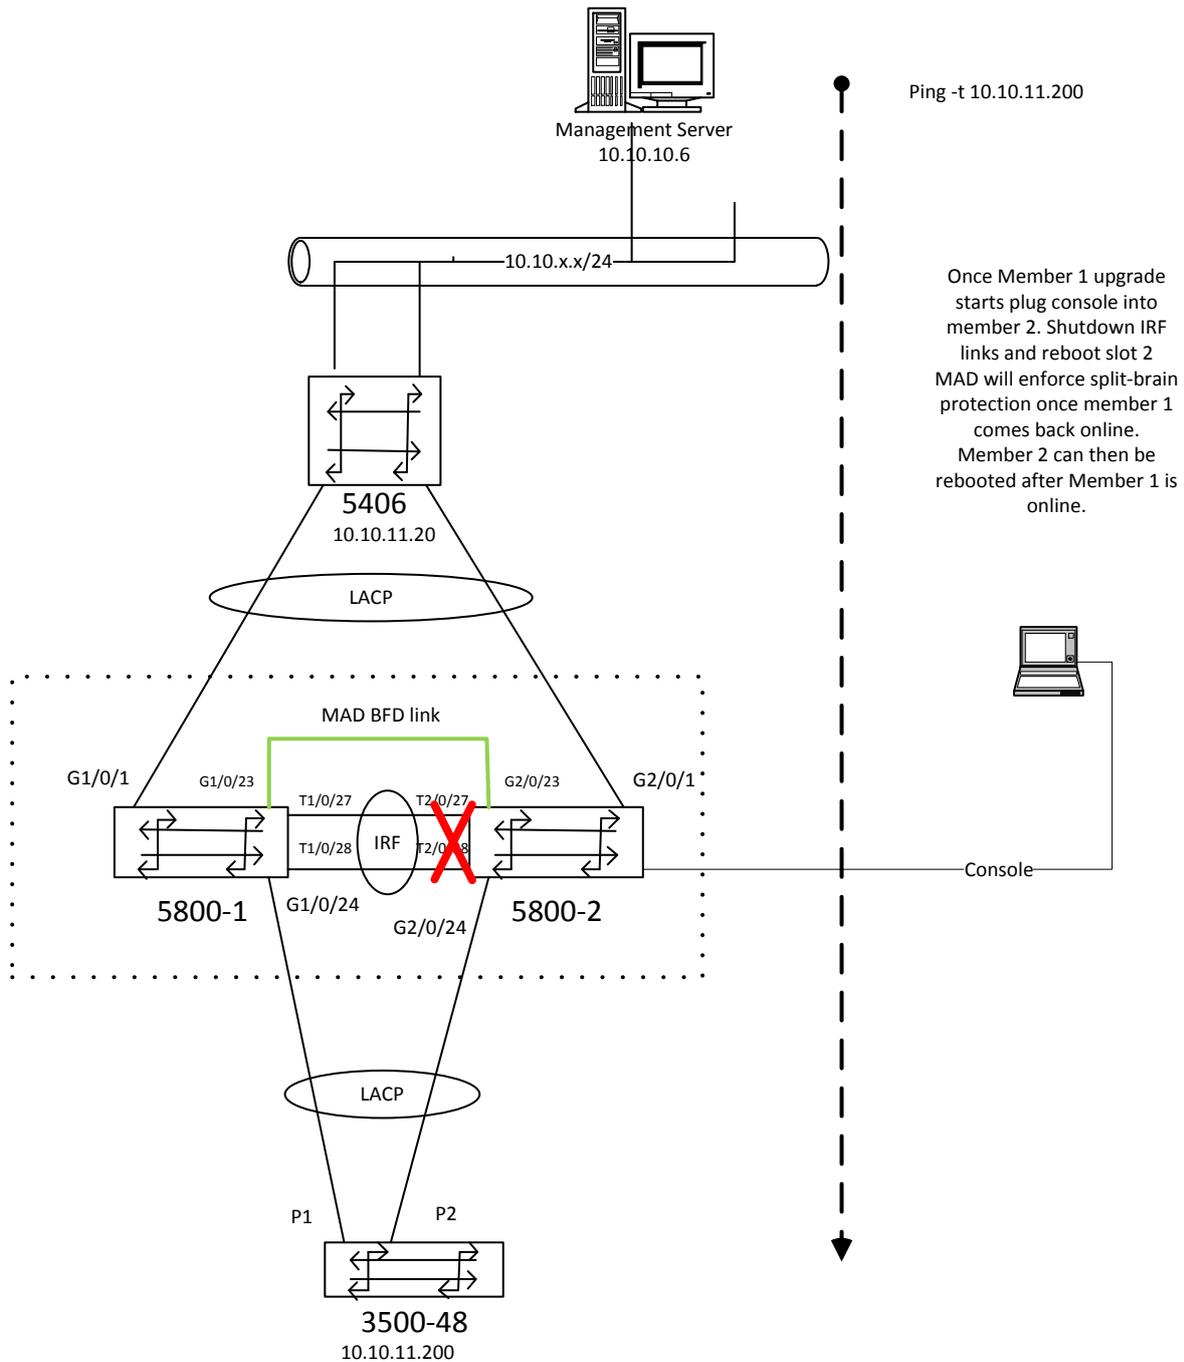
Figure 2: Reboot process

Plug into member 2 console and Reboot slot 1

1. It is critical to configure MAD first, and to start the update process on the member that would "win" the MAD process, the member with the lowest member ID, typically member 1
2. Note the 10G ports which are used by IRF (display irf configuration)
3. Copy firmware images to both units, configure the boot-loader to use the new images. Do not reboot yet.
4. Reboot member 1 (reboot slot 1), member 2 will resume the master role.

6. Member 1 will come online with the new version, once it comes online, MAD will come into action and member 2 will shutdown all its external interfaces. At this moment the link-aggregation failover has occurred (like the "switchover" command for the normal ISSU).
